Project: Gripple Hangfast

Bescheinigung über die Prüfung von Lastaufnahmemittel *Gripple Hang Fast*

**Fire performance of
innovative hanger
system**

Executive Summary

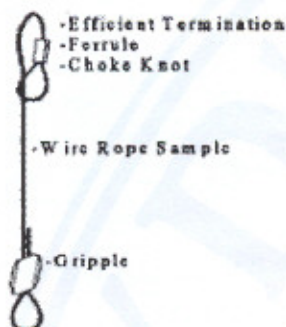
Gripple Hangfast No1, No2, No3, No 4, and No5 Test Configuration

Hangfast Model	MBL of Wire Rope (Galvanised)	Rope Construction	Working Load Limit (WLL)	Failure Load of test	Mode of failure
No. 1	80 kg	7 x 7 (6/1)	10 kg (22 lbs)	85 kg	Wire Break. Housing undamaged
No. 2	260 kg	7 x 7 (6/1)	35 kg (77 lbs)	255 kg	Wire Break. Housing undamaged
No. 3	580 kg	7 x 7 (6/1)	80 kg (176 lbs)	555 kg	Wire Break. Housing undamaged
No. 4	1500 kg	7 x 19 (12/6/1)	225 kg (495 lbs)	1800 kg	Wire Break. Housing undamaged
No. 5	2160 kg	7 x 19 (12/6/1)	325 kg (715 lbs)	2150 kg	Wire Break. Housing undamaged

The above tests were witnessed and found satisfactory. No deformation was observed on the Gripple Hangfast components that were visually examined on completion of the test.

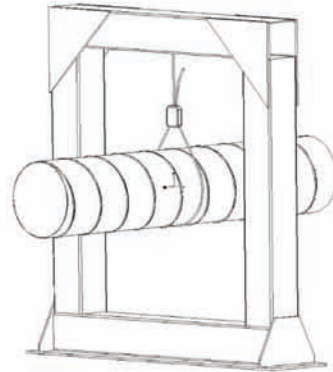
The tests were carried out on a rigid 'goal post' frame manufactured from rolled hollow section welded together with gusset plates welded at each joint, top and bottom. A 600 mm section of 160 mm diameter spiral duct was suspended from the frame using:

A 20 mm dia. x 30 mm long steel cylinder with an oscillating motor acted as a vibration source.

Using a Bruel and Kjaer type 2511 vibration metre with a 4370 accelerometer, displacement readings were taken at:

- (A) the junction of the duct and suspension
(B) the top of the frame

From these readings comparative percentage isolation values were derived using the formula: $\frac{\text{Displacement at (A)} - \text{Displacement at (B)}}{\text{Displacement at (A)}} = \% \text{ isolation (absorption)}$

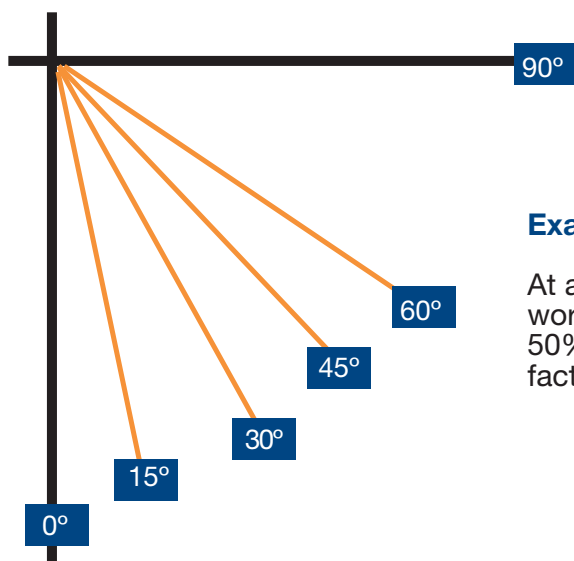
In many cases, the position of the suspension point and the presence of certain suspension constraints makes it necessary to suspend an object at an angle. If the wire rope is suspended at an angle, an additional sideways load is applied which reduces the load capacity of the suspension. The table below shows the variations in safe working load in relation to the angle of suspension.

Grippler hanger size	Maximum safe working load (kg) at an angle from the vertical:				
	Verticale 0°	15°	30°	45°	60°
No.1	10	9	8	7	5
No.2	45	43	38	31	22
No.3	90	86	77	63	45
No.4	225	217	194	159	112
No.5	325	313	281	229	162
Loss of load capacity %	0	4	14	30	50

At an angle of 60° to the vertical, the working load must be reduced by 50% in order to maintain a safety factor of 5:1

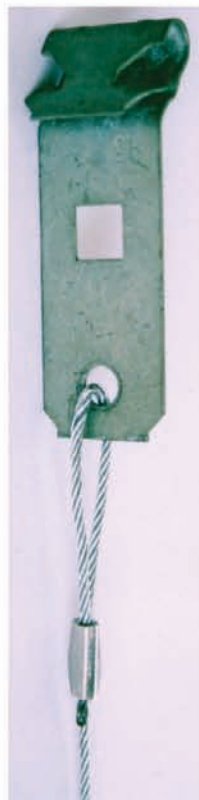
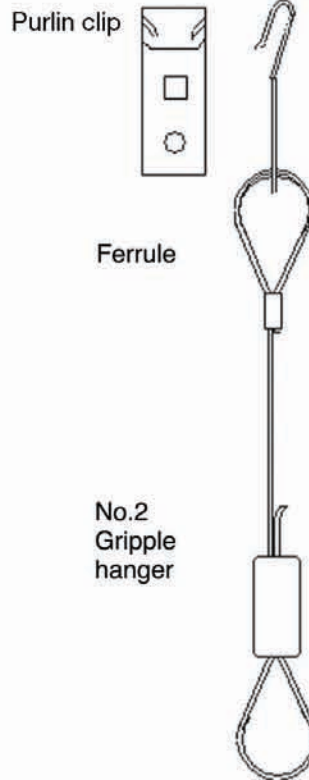
Tensometer testing of No.2 hanger purlin clip

The integrity of the wire rope strands, physically bearing on the purlin clip, was maintained in each test. No strands broke at the purlin clip. For test purposes the clip was secured to the assembly using a ferrule. The assembly was secured in the tensometer machine using a No 2 Gripple at the other end.

Sample No.	Breaking Load kg	Comment
1	291	wire break at Gripple fastener
2	255	wire break at Gripple fastener
3	295	wire break at Gripple fastener
4	282	wire break at Gripple fastener
5	286	wire break at Gripple fastener

In each test, the wire rope broke at a load that was at least 5 times greater than the SWL of the Gripple hanger. The test fully confirmed the tensile strength of the wire rope.

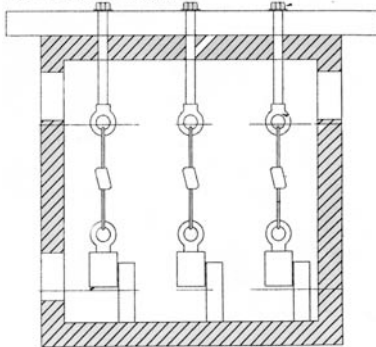
Figure 1. Furnace Arrangement

The Gripple Hangers were placed in a furnace constructed by CIFL for the test as shown in Figure 1

The hangers were suspended from eye nuts attached to M16 threaded bar held on a supporting construction. The loop end of the wire rope was attached to the eye nuts.

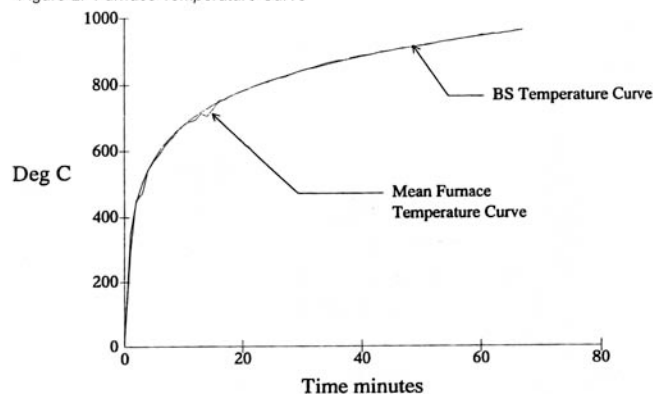
Figure 2. Furnace Temperature Curve

The furnace was controlled to follow the temperature/time relationship specified in BS 476 : Part 20 : 1987 as shown in Figure 2 using four thermocouples distributed within the furnace.

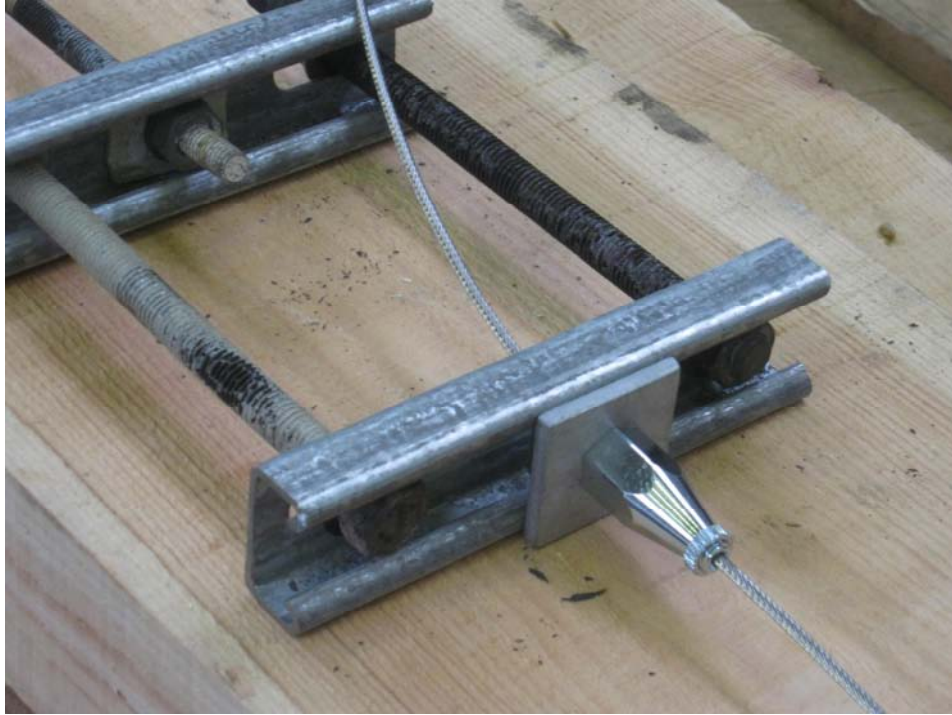
Figure 1 “Gripple” fixing attached to channel

In each case the load was applied by hanging a weight to a length of channel fixed to the cable by means of a “Gripple” fixing (Figure 1). The fixing to the other end was attached to a threaded bar suspended above the furnace and varied for each test in accordance with the description in the table above. The fixings are illustrated in Figures 2-4. In each case the cable was a stainless steel wire rope of 3mm diameter. In each case both fixings were entirely contained within the furnace.

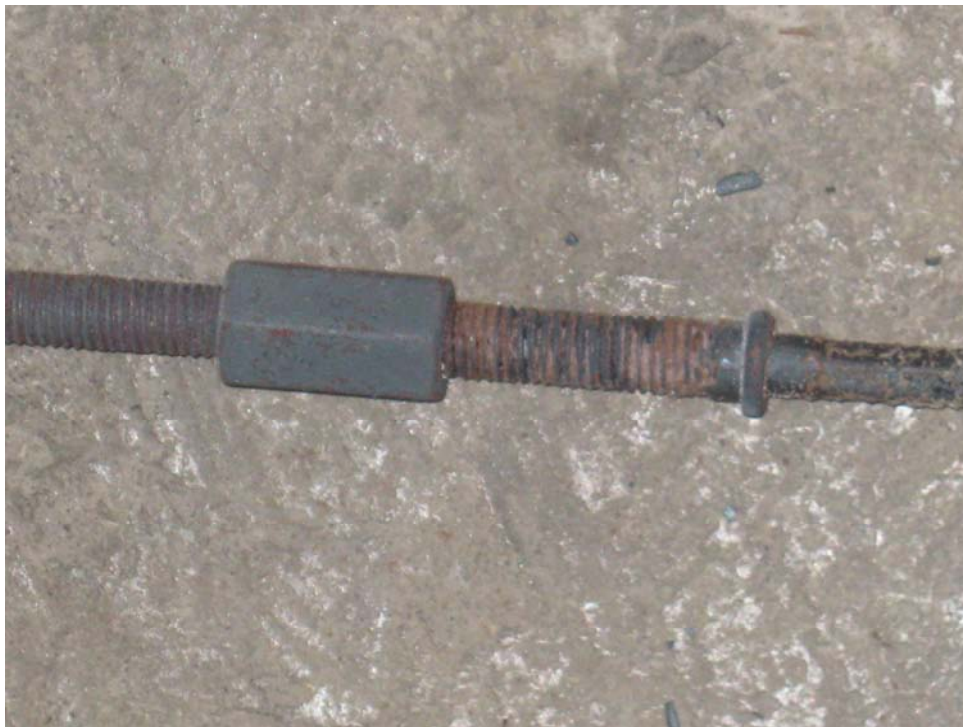
Figure 2 M8 stud end fixing connected to M8 stud

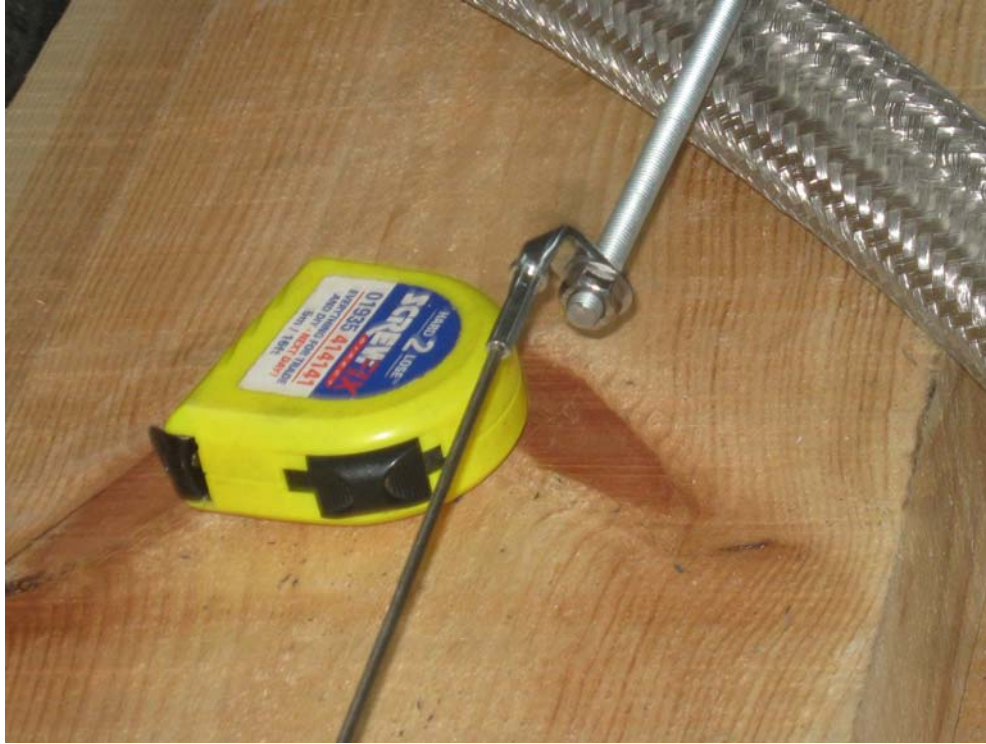
Figure 3 90° eyelet end fixing connected to M8 stud

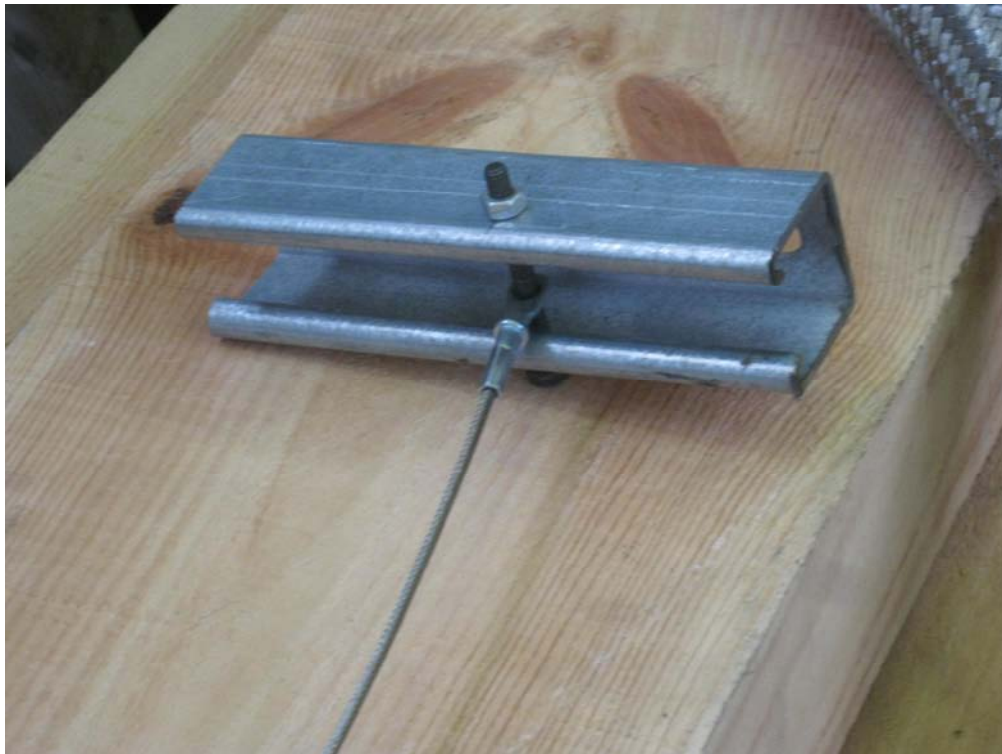
Figure 4 Straight eyelet end fixing connected to channel

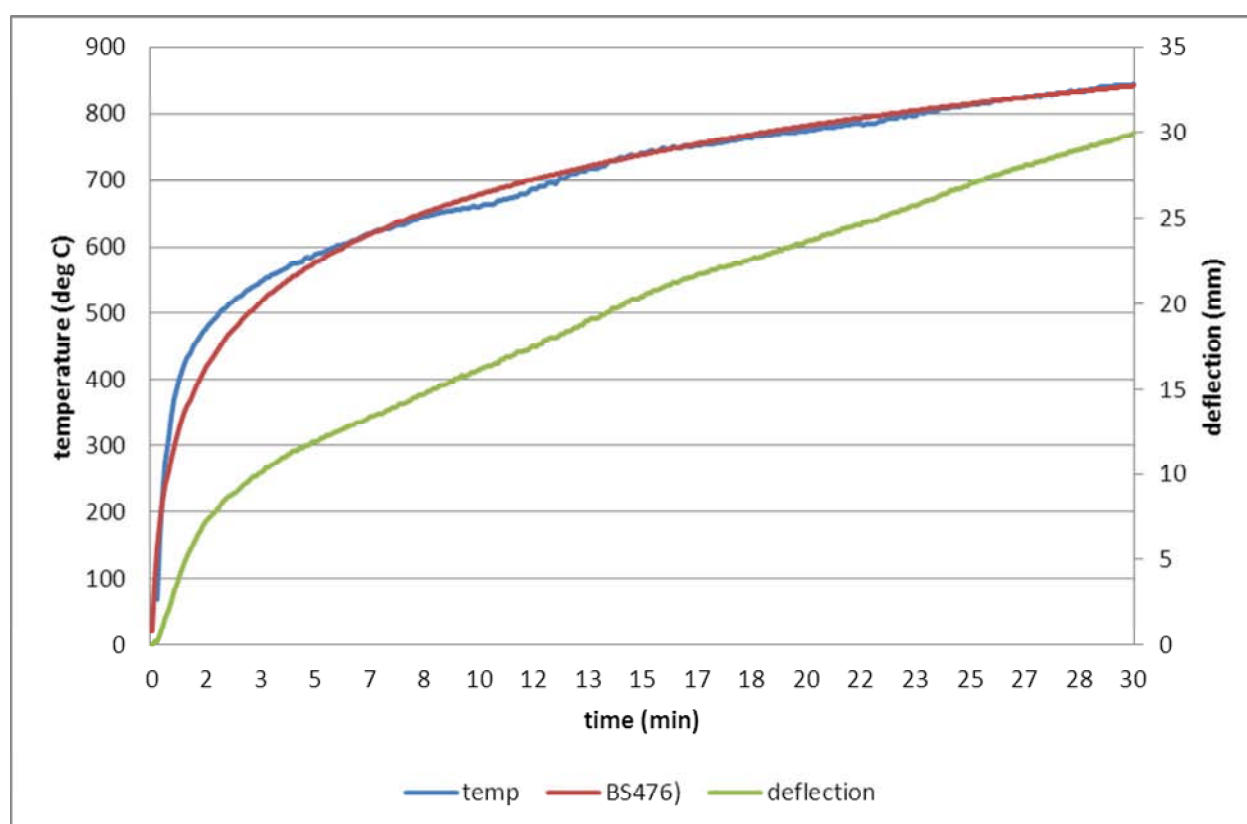
Figure 5 Results from Group 1 test 1

The results from the first fire test are shown in Figure 5 below. The measured temperature within the furnace is shown alongside the standard (BS476) fire curve. The results indicate a good agreement between the measured temperature and the standard curve. The maximum deflection was approximately 30mm after 30 minutes. The system continued to support the applied load for the test period. The sample is shown on removal from the furnace in Figure 6. The sample comprised both the Gripple unit and M8 stud end fixing and approximately 750mm of the wire rope. At the end of the test the sample appeared to be supported on the bottom of the furnace (Figure 7). However for the 30 minute test period the sample continued to deflect so it is likely that the sample was supported on the bottom of the furnace after the test was completed.

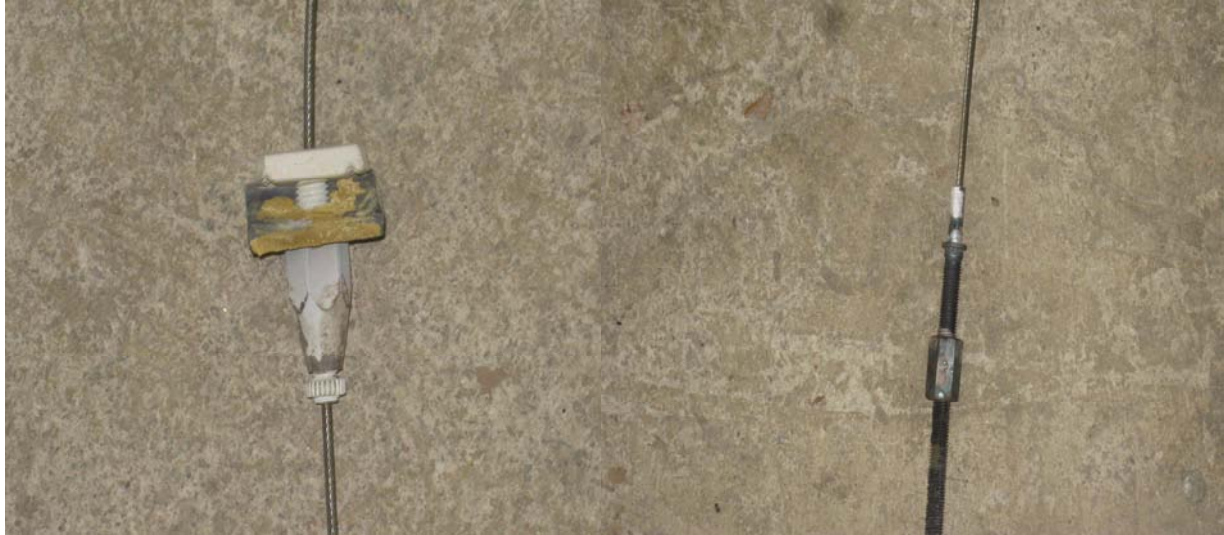
Figure 6 Fixings on removal from the furnace

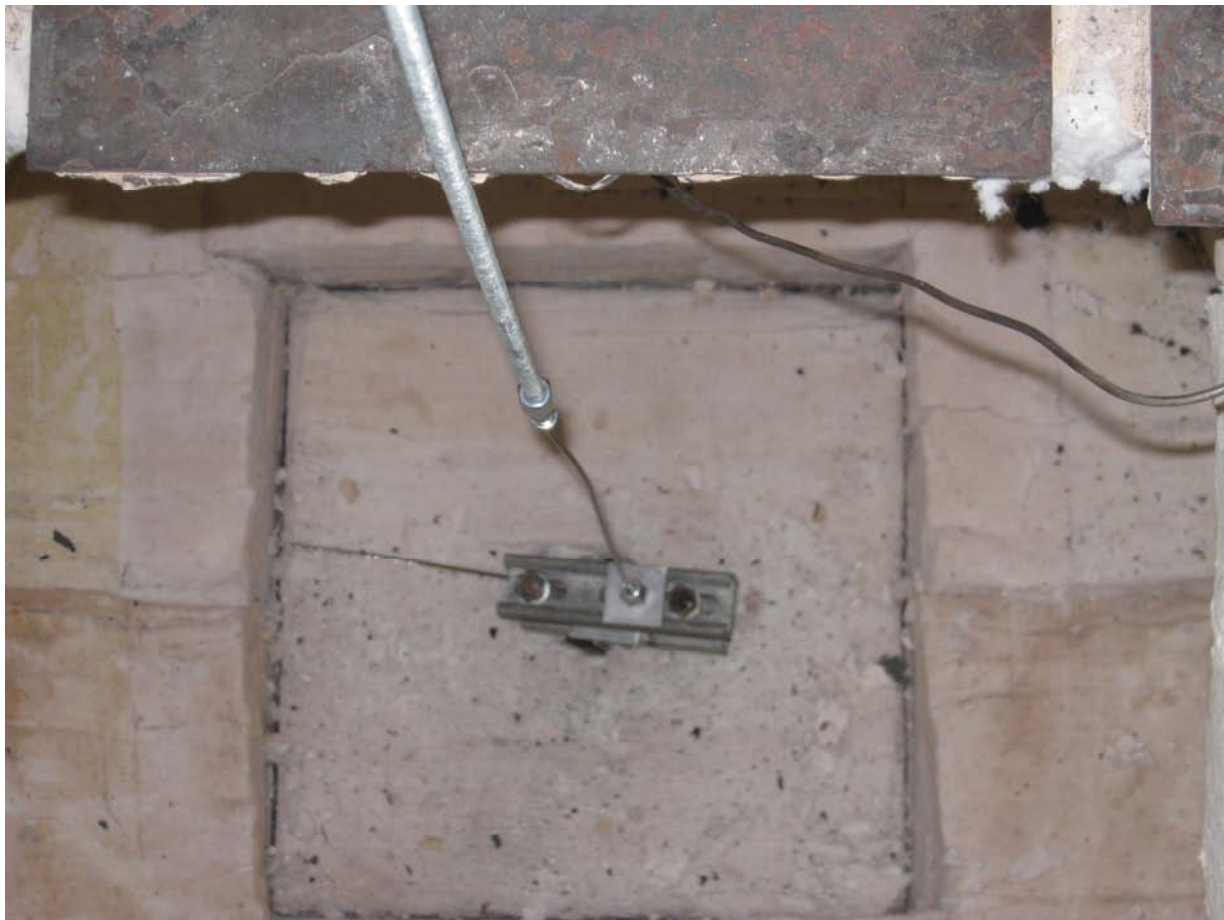
Figure 7 Sample supported on bottom of the furnace at the end of the test

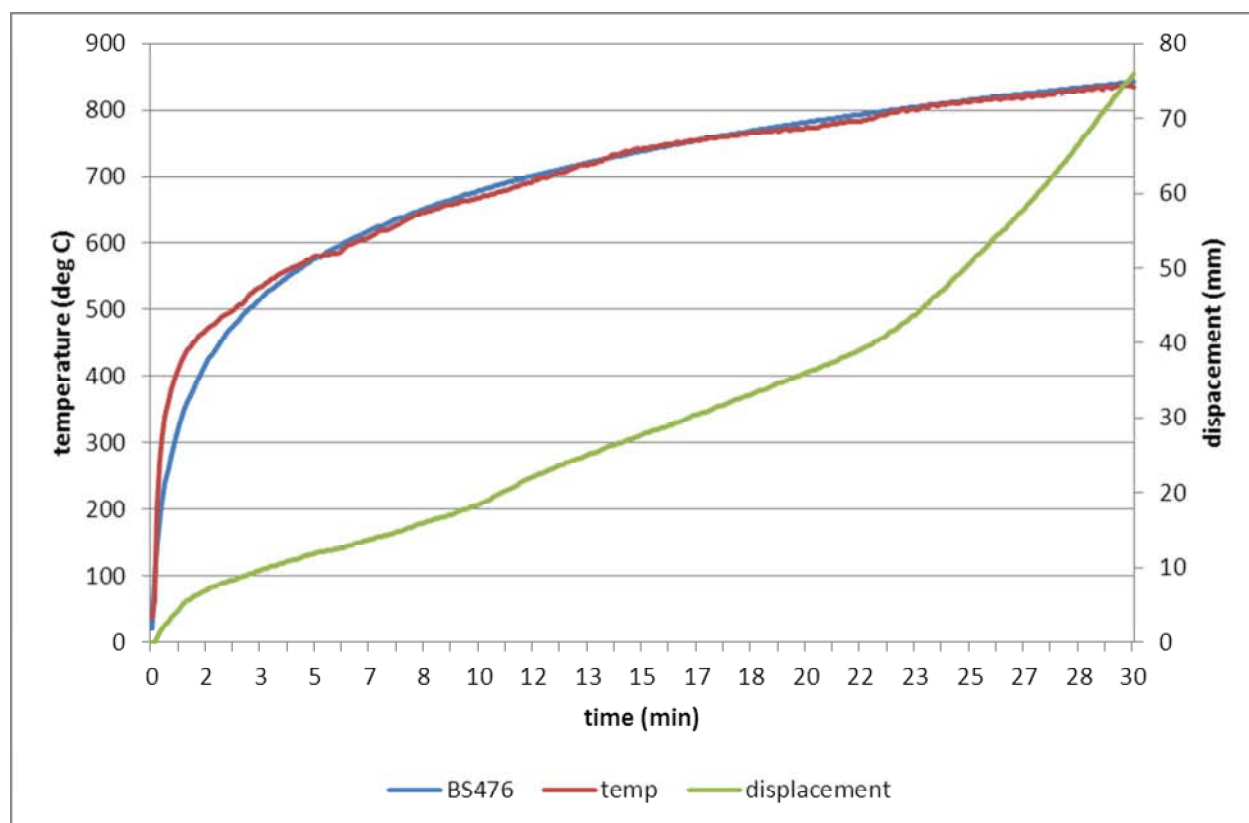
Figure 8 Results from Group 1 test 2

The results from the second test are shown in Figure 8. Again there is good agreement between the measured temperature within the furnace and the standard fire curve. The system supported the load for the duration of the test. The maximum deflection was approximately 76mm at 30 minutes. The sample is shown on removal from the furnace in Figure 9.

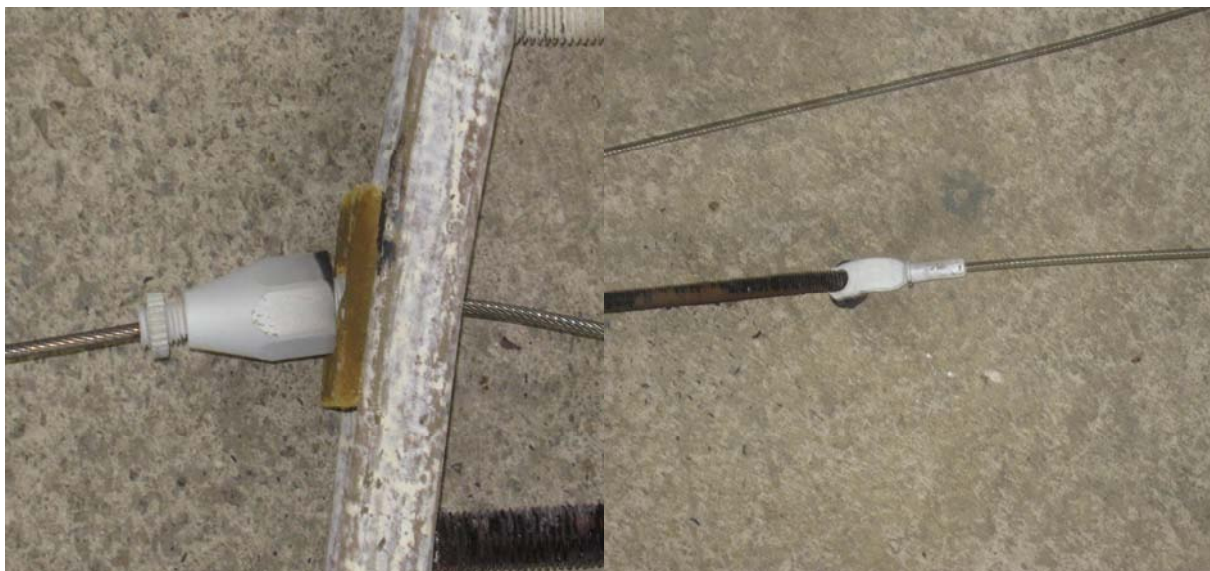
Figure 9 Fixings on removal from the furnace

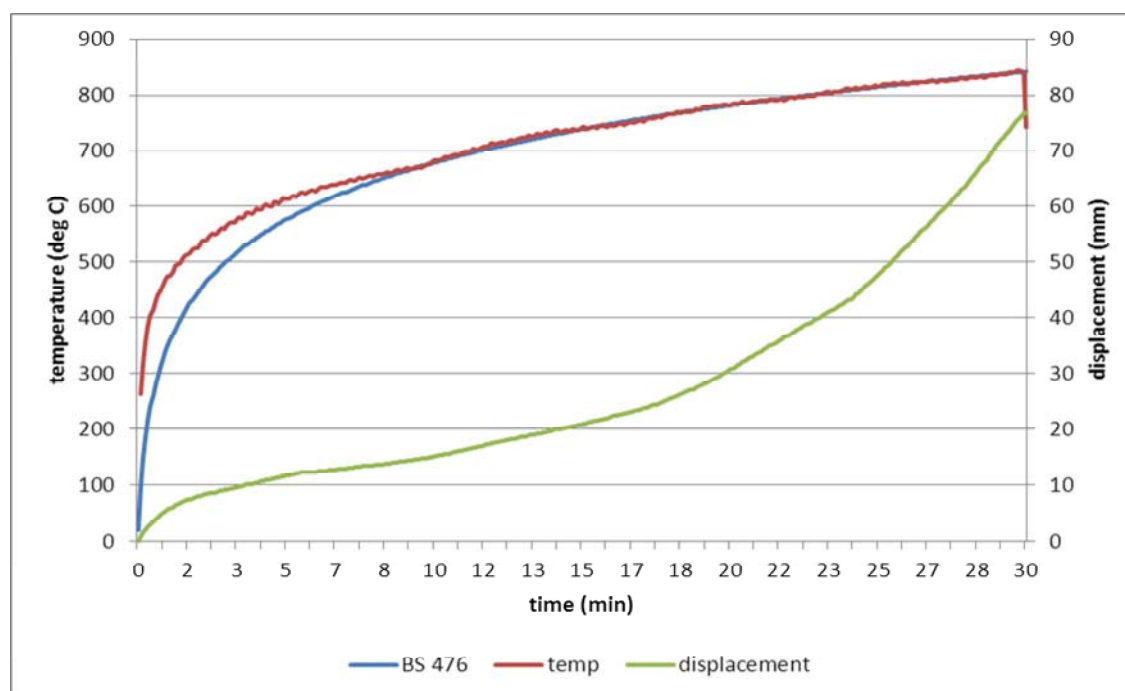
Figure 10 Results from Group 1 test 3

The results from the third test are shown in Figure 10. The system supported the load for the duration of the test. The maximum deflection was approximately 77mm at 30 minutes. The sample is shown on removal from the furnace in Figure 11.

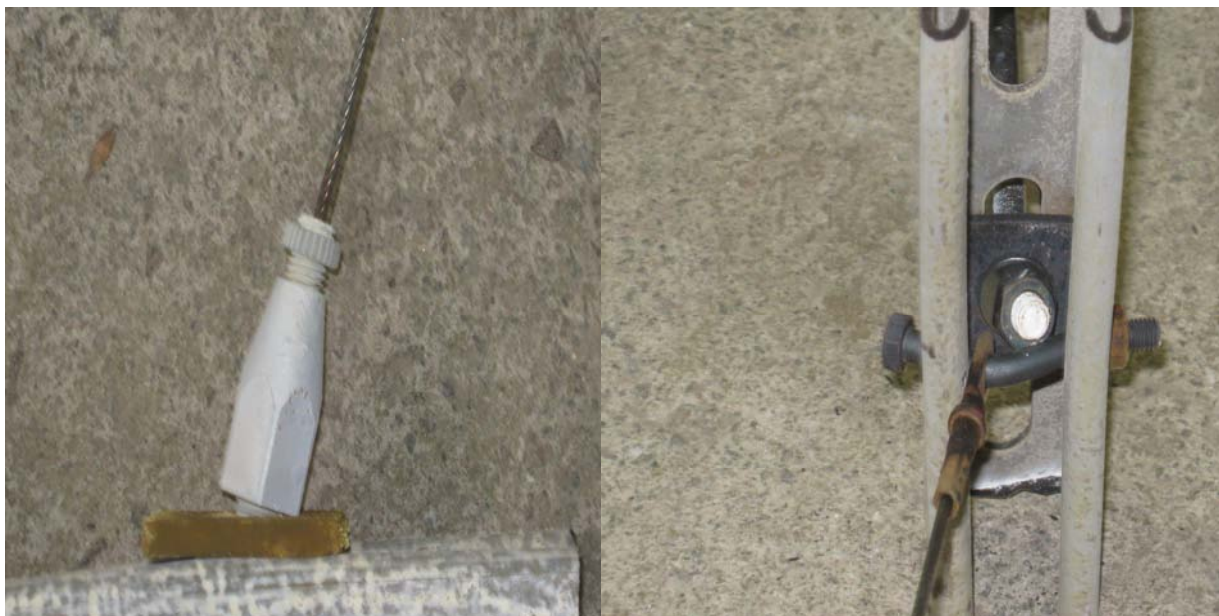
Figure 11 Fixings on removal from the furnace

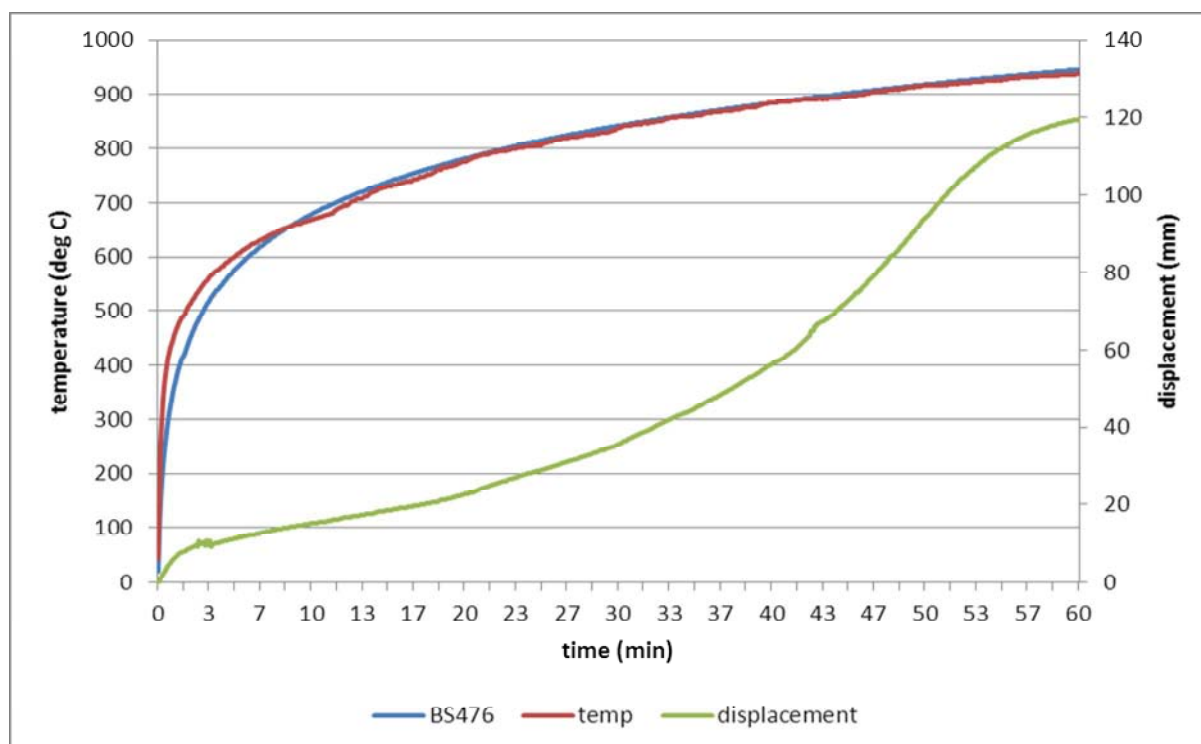
Figure 12 Results from Group 2 test 1

The results from the fourth test are summarised in Figure 12.

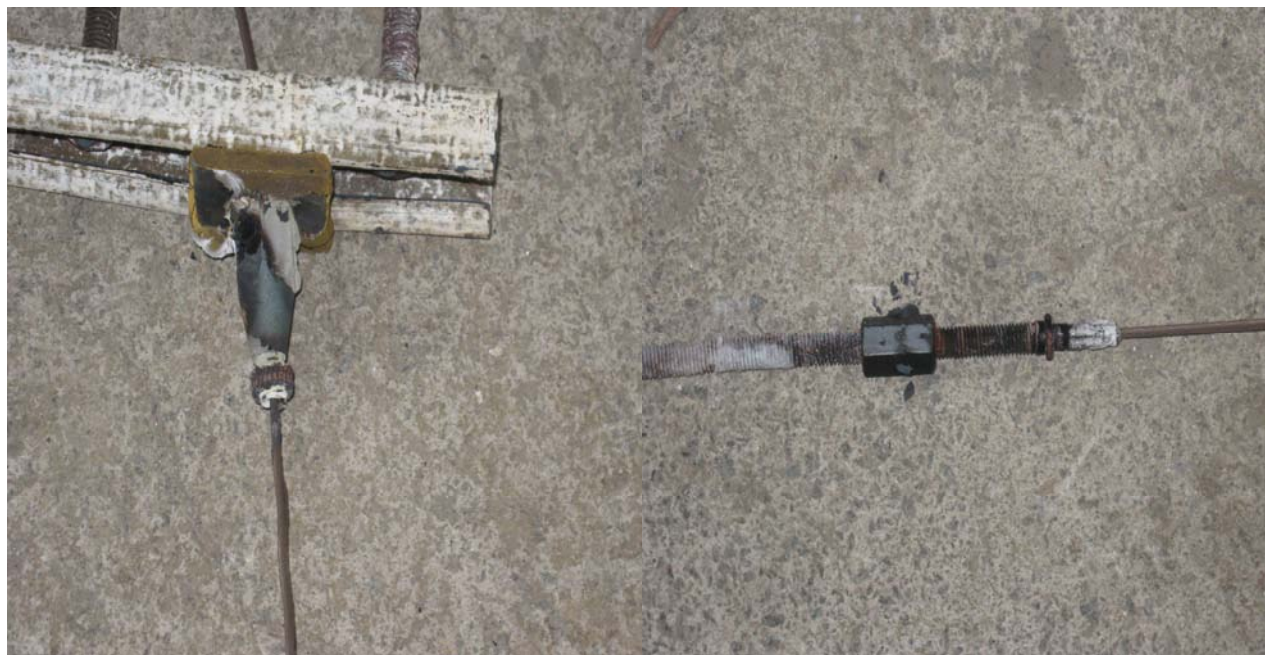
Figure 13 Fixings on removal from the furnace

The system supported the load for the duration of the test. The maximum deflection was approximately 120mm at 60 minutes. The sample is shown on removal from the furnace in Figure 13.

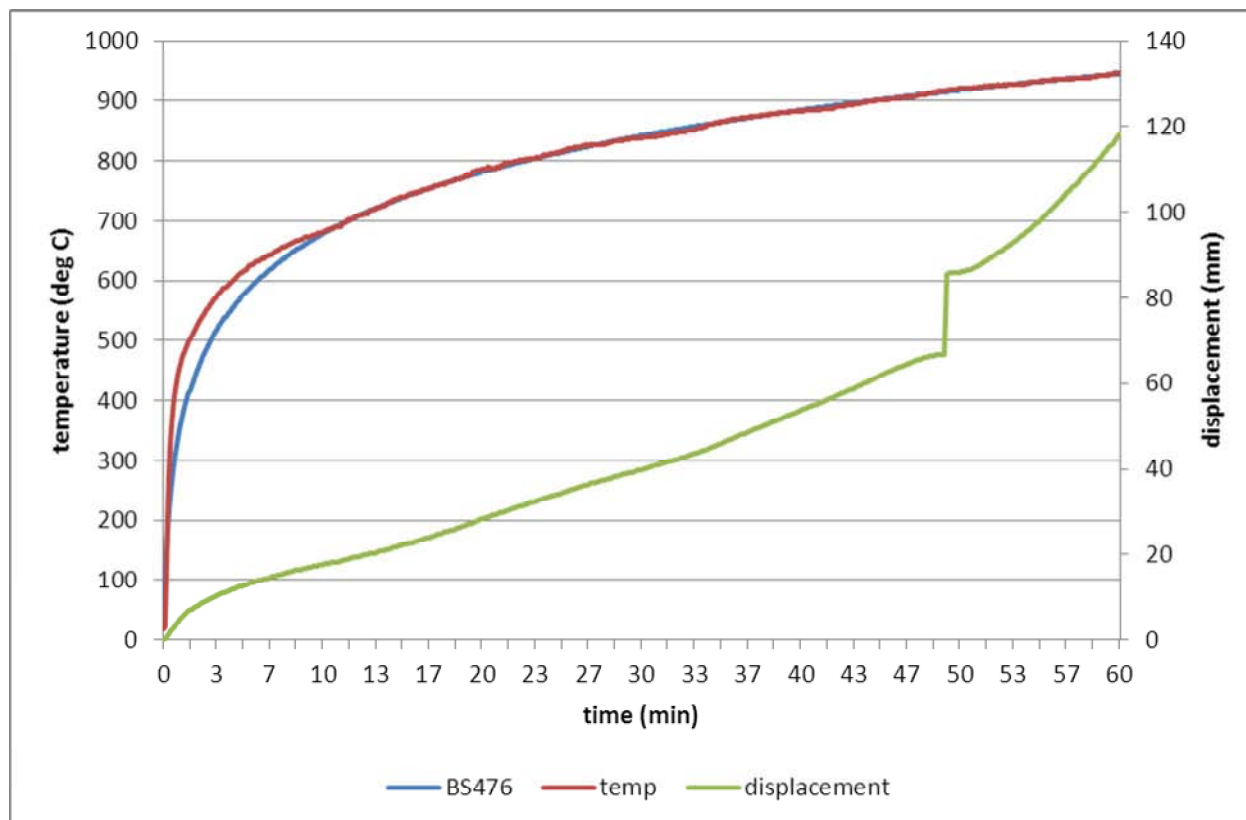
Figure 14 Results from Group 2 test 2

The results for the fifth test are summarised in Figure 14. The system supported the load for the duration of the test. The maximum deflection was approximately 118mm at 60 minutes. There is no clear reason for the increase in deflection between 48 and 49 minutes into the test although it may have been caused by deformation of the loading frame. The sample is shown on removal from the furnace in Figure 15. In this case the test was continued until failure which occurred at 69 minutes.

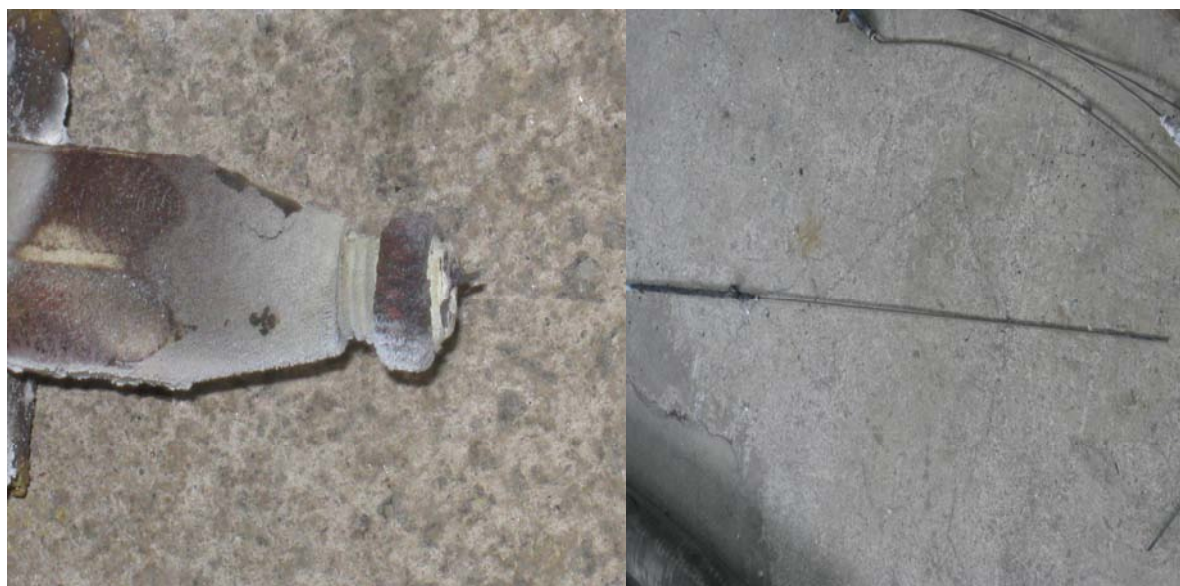
Figure 15 Fixings on removal from furnace

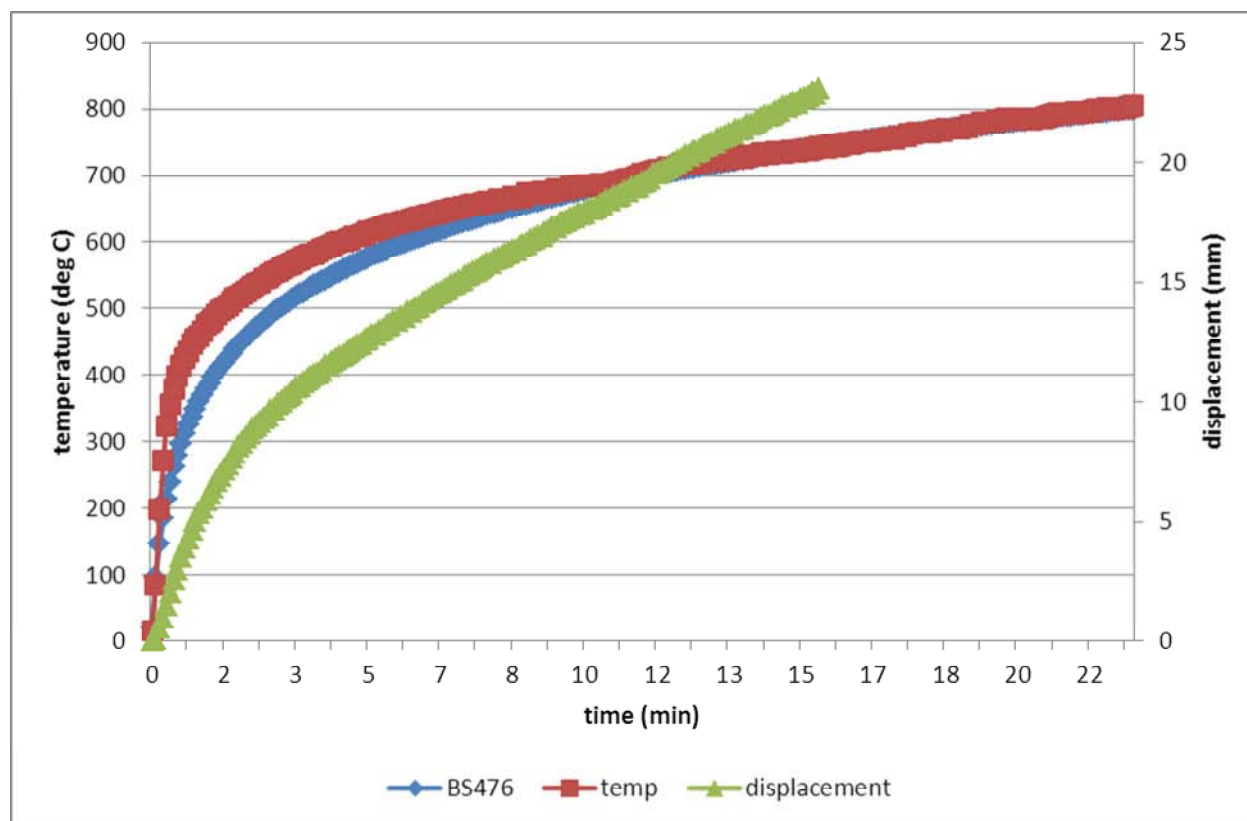
Figure 16 Results from Group 2 test 3

The results for the sixth test are summarised in Figure 16. There were problems with the data logging system for this test. The displacement transducer stopped recording after approximately 15 minutes and all communication with the data logging system was lost after approximately 23 minutes. The test was continued for 60 minutes. The system supported the load for the duration of the test. The sample is shown on removal from the furnace in Figure 17.

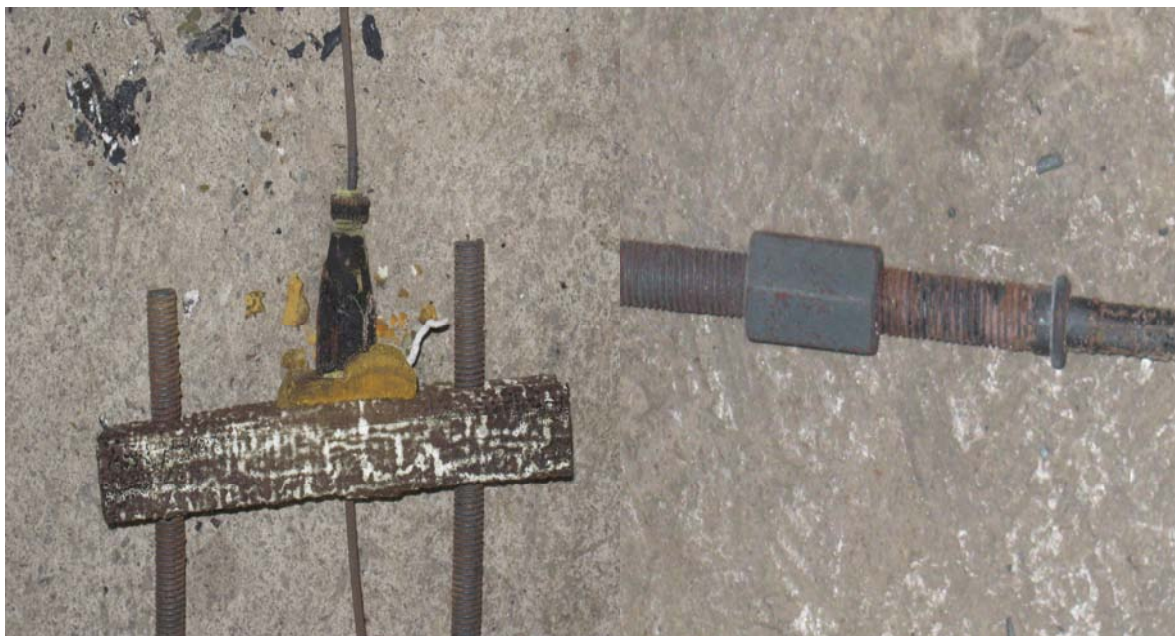
Figure 17 Fixings on removal from the furnace

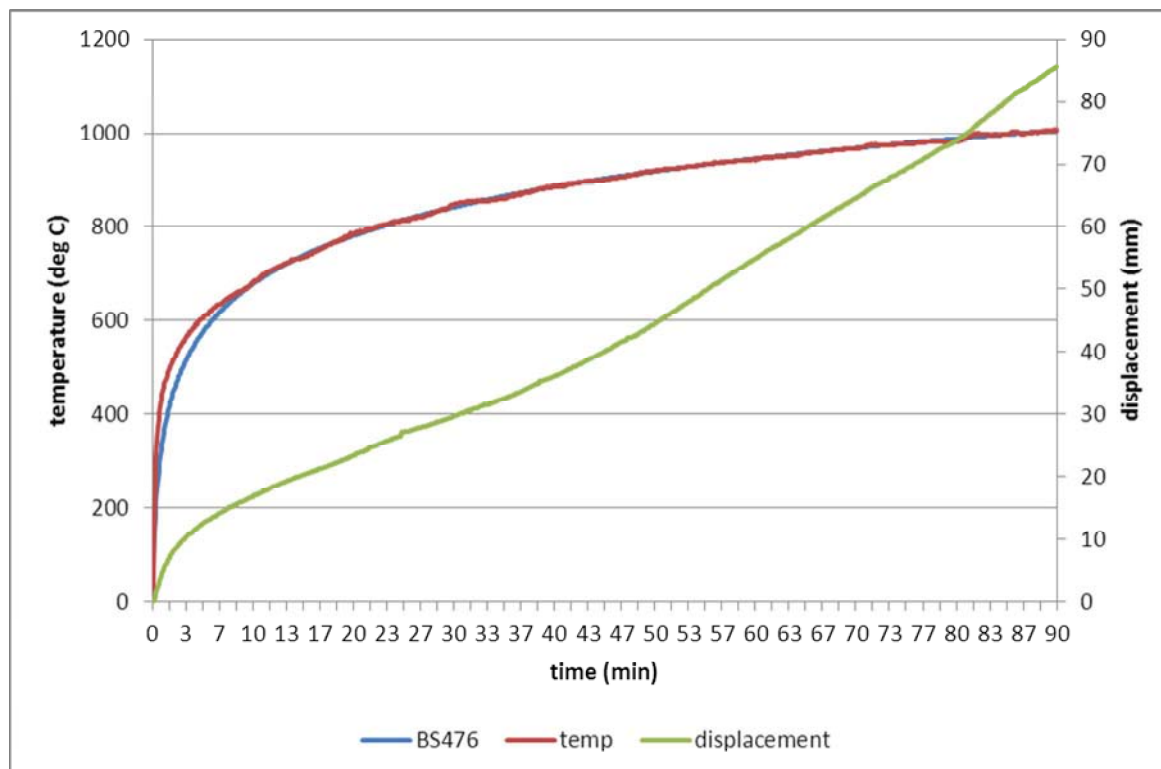
Figure 18 Results from Group 3 test 1

The results for the seventh test are summarised in Figure 18. The maximum deflection is approximately 86mm at 90 minutes. The system supported the load for the duration of the test. The sample is shown within the furnace in Figure 19.

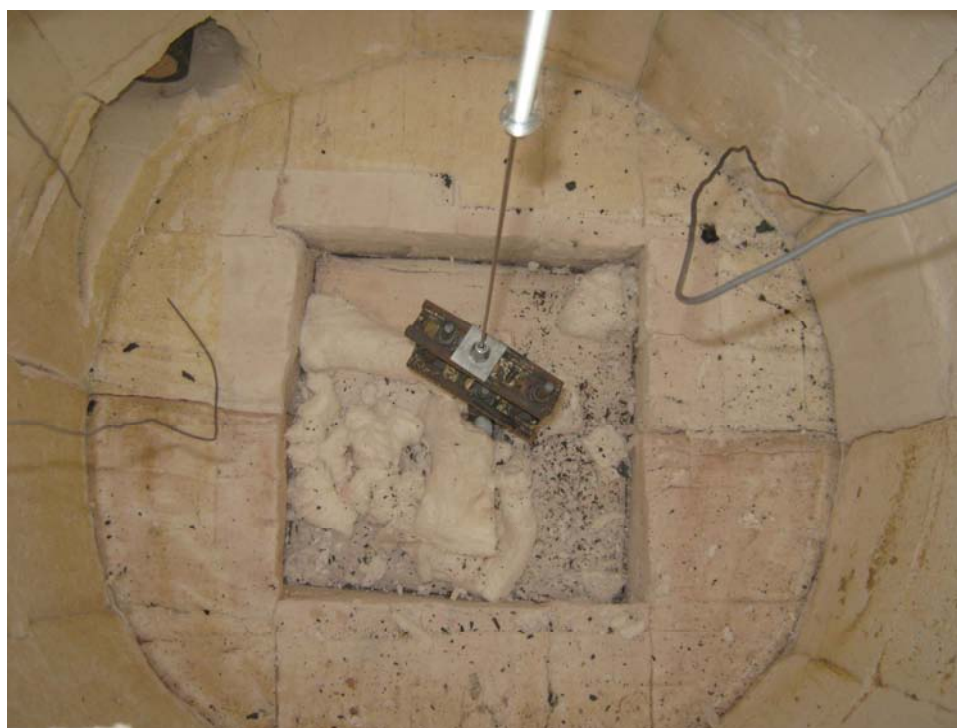
Figure 19 Sample within the furnace

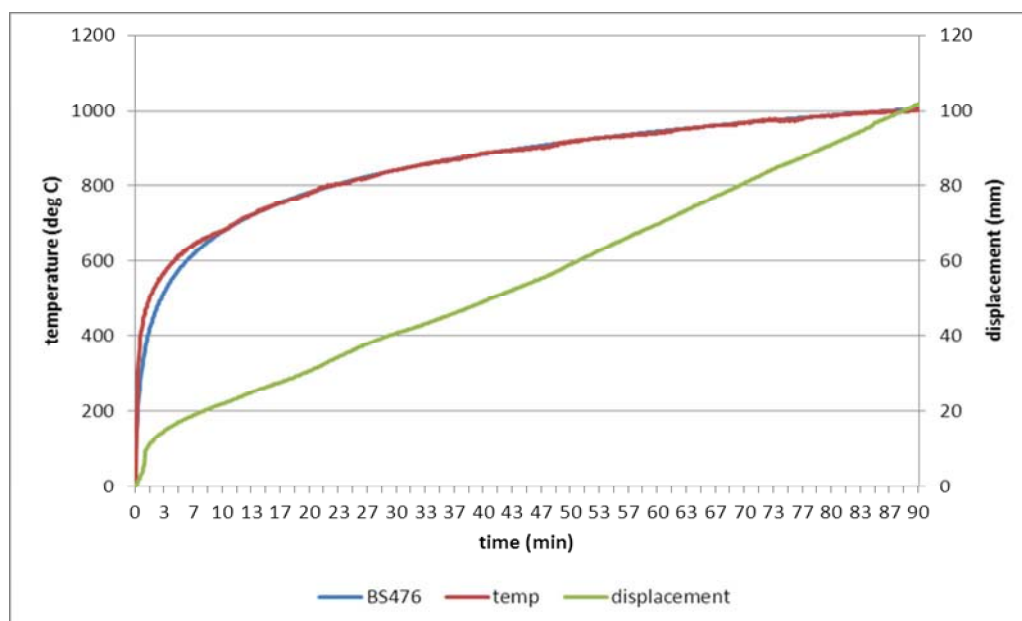
Figure 20 Results from test 8

The results from the eighth test are summarised in Figure 20. The system supported the load for the duration of the test. The maximum deflection was approximately 101mm at 90 minutes. The sample is shown within the furnace in figure 21.

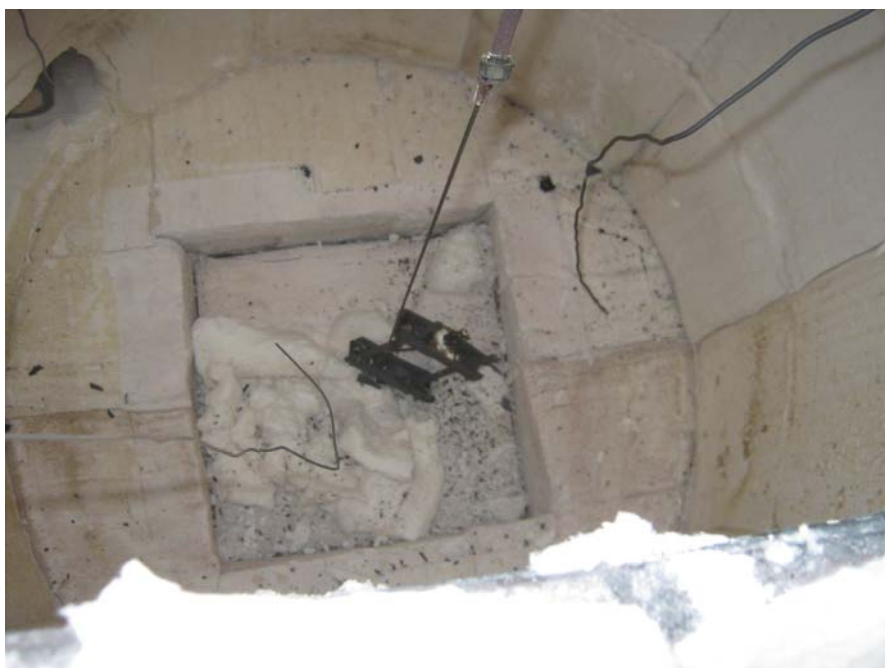
Figure 21 Sample within the furnace

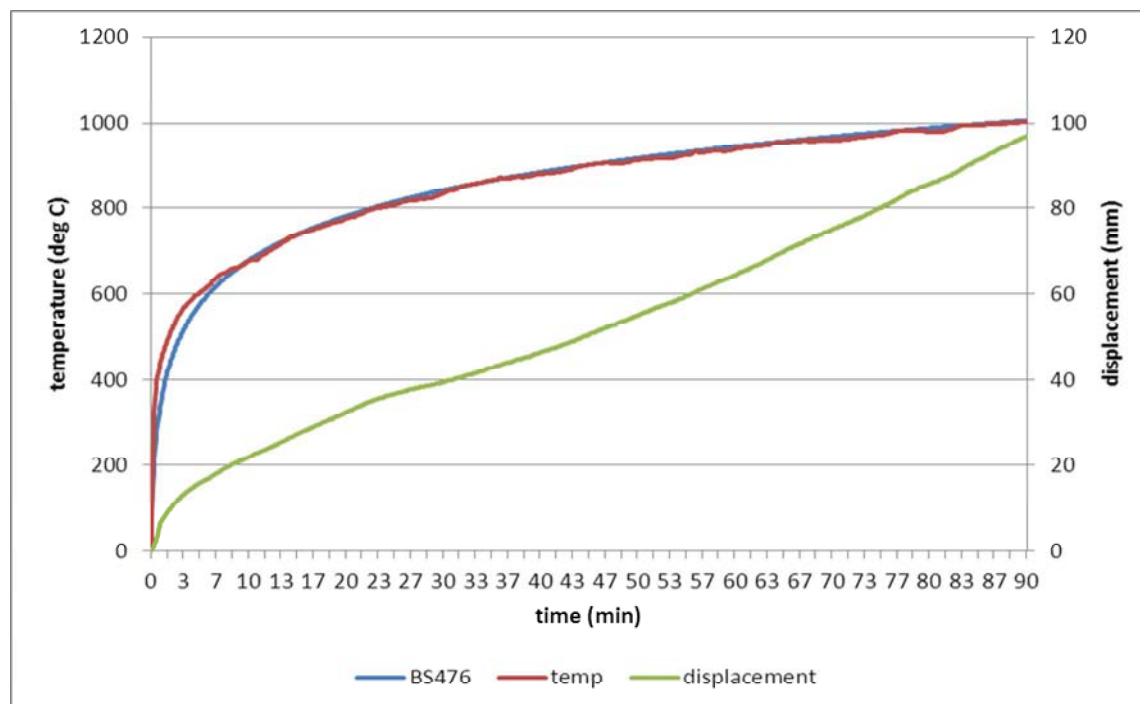
Figure 22 Results from Group 3 test 3

The results from the ninth test are summarised in Figure 22. The maximum deflection is approximately 89mm at 90 minutes. The sample is shown on removal from the furnace in Figure 23.

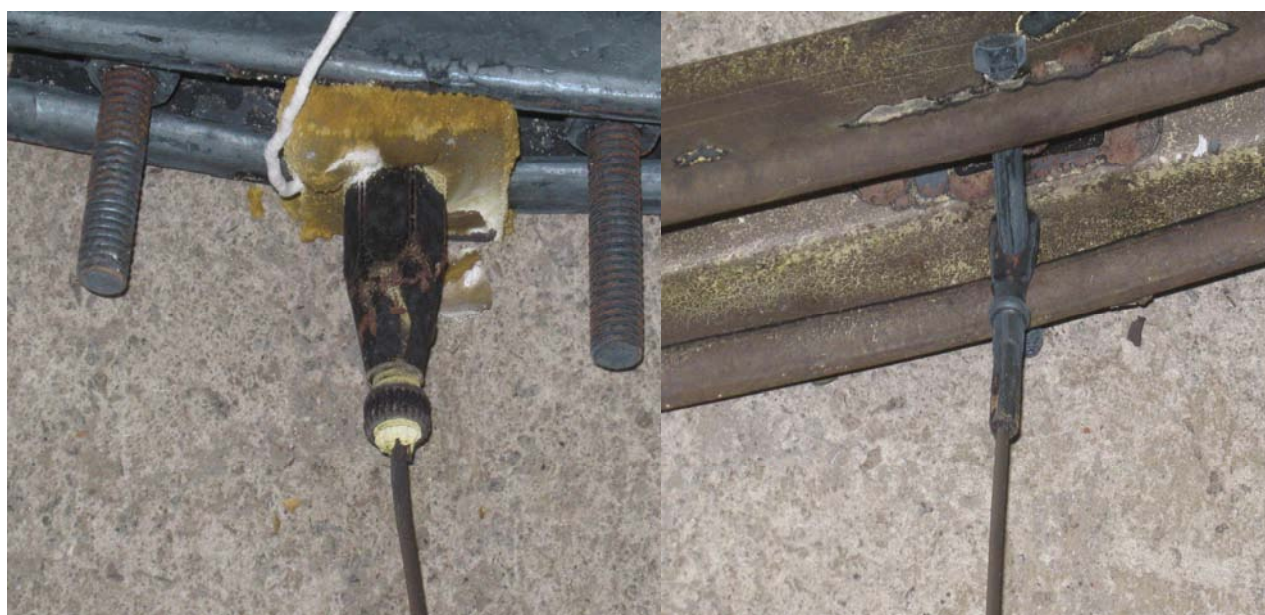
Figure 23 Fixings on removal from the furnace
